PW Parkway ES

WSSI #21315.03

Perennial Flow Determination

November 10, 2015

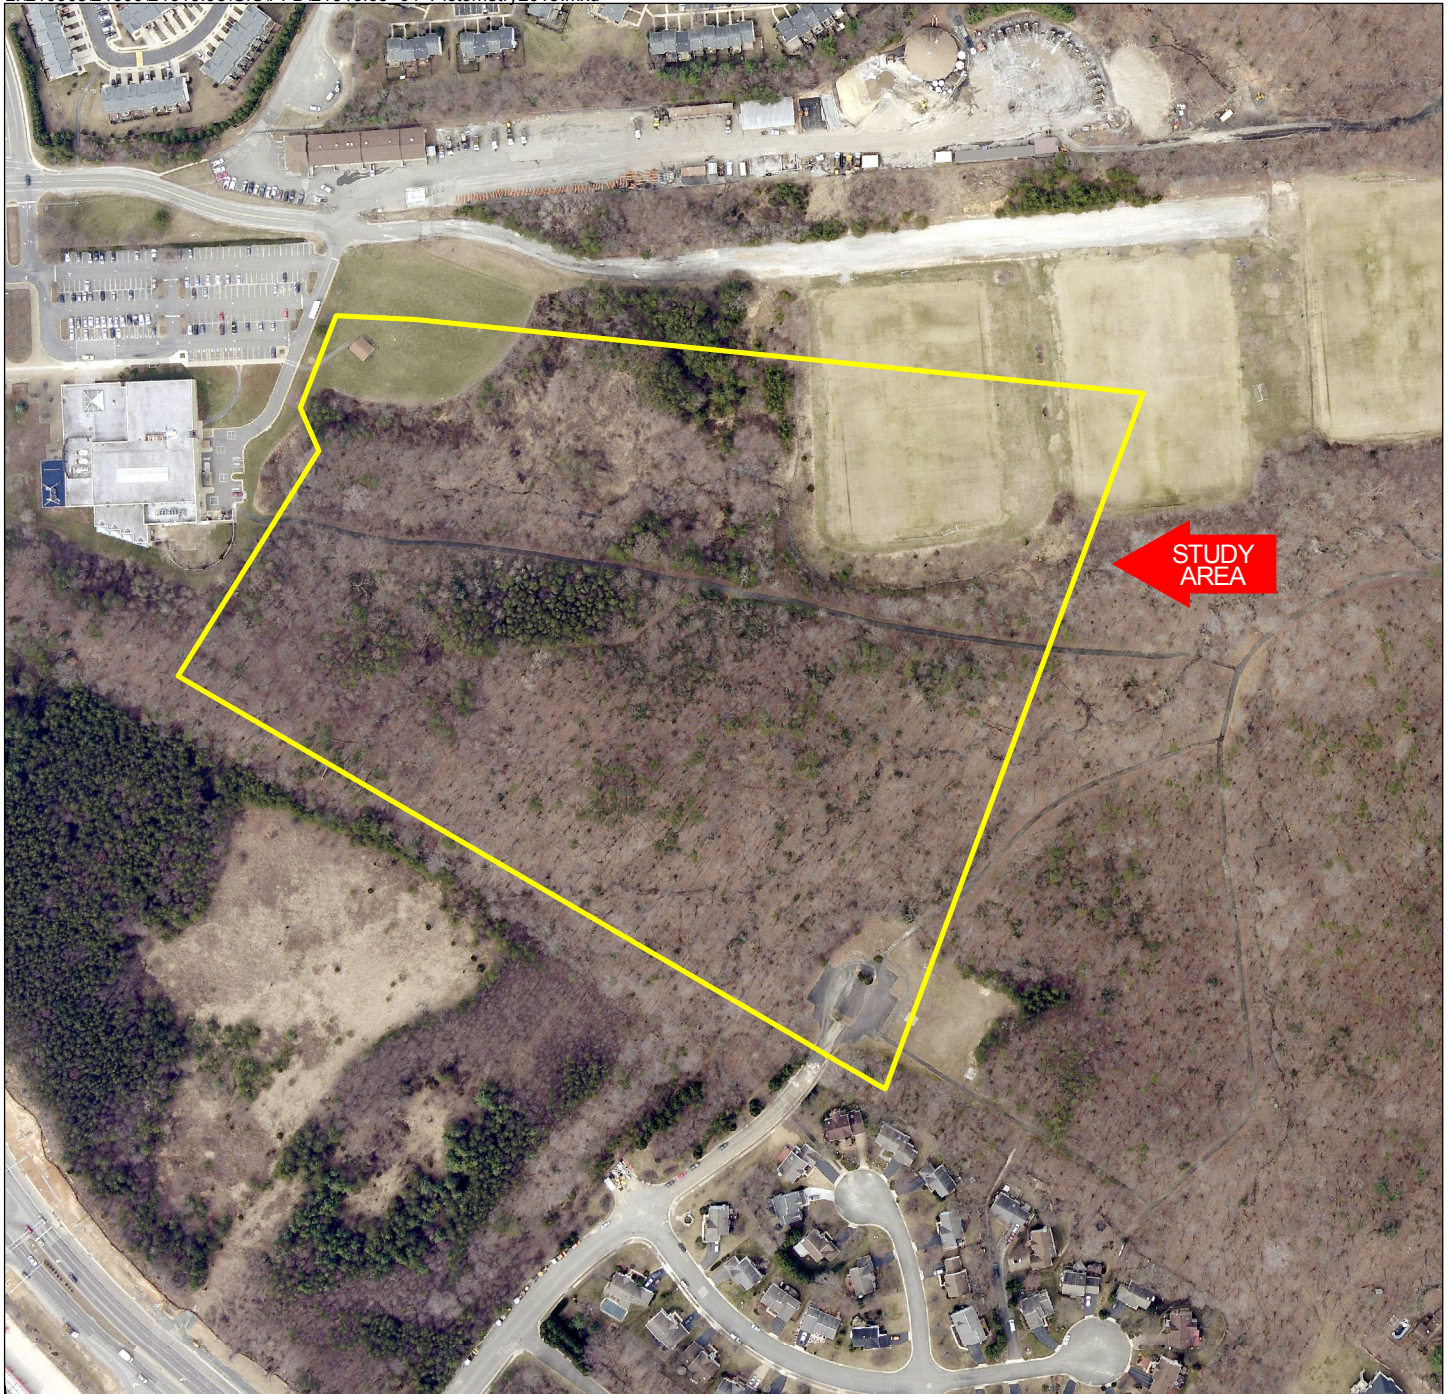
Exhibit 4

March 2015 Natural Color Imagery
PW Parkway ES
WSSI #21513.03
Original Scale: 1" = 300'

Exhibit 1 is a vicinity map that shows the approximate boundaries of the PW Parkway ES study area and its general vicinity. The study area is located southeast of the intersection of Prince William Parkway (Route 3000) and Old Bridge Road at the terminus of Trowbridge Drive in Prince William County, Virginia. The study area consists of maintained recreational fields in the northern portion of the study area, a parking lot in the southern portion of the study area, and a mature, mixed hardwood forest in the remainder of the study area with small paved trails throughout. The study area is slightly sloped with drainage toward the north and the south, in the direction of the unnamed tributaries. The study area topography can be seen in Exhibit 2 and in the background topography on the Perennial Flow Determination Map (Attachment I). The Prince William County Resource Protection Area map is included as Exhibit 3 and the March 2015 natural color imagery from Pictometry® of the study area is included as Exhibit 4.

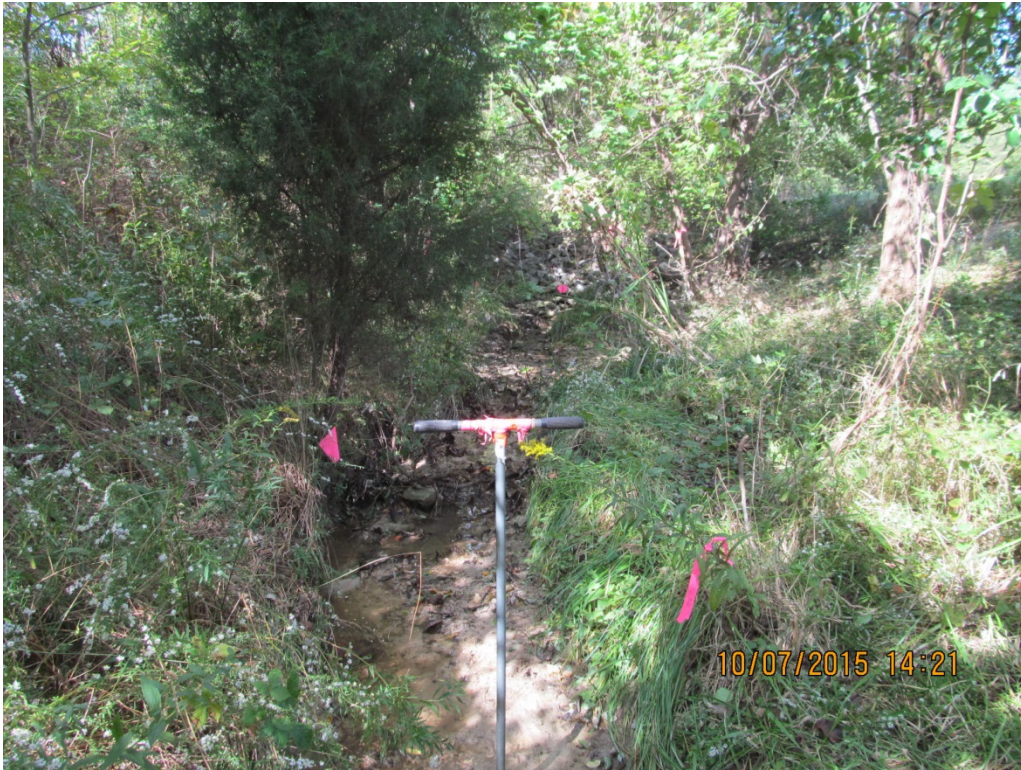
1. Looking north (upstream) at Stream Reach 1-A, an intermittent stream present in the northern portion of the study area. This stream scored 22.25 and 16.5 on the NCDWQ and DPWES methods, respectively. Stream assessment scores below the intermittent/perennial threshold, combined with weak geomorphology and weak baseflow, indicate that flow within this stream is intermittent.

- Stream Reach 1-A (Photos #1 and #2) characterizes the stream flagged with the B/D flagging series in the northern portion of the study area. This 2- to 3-foot wide stream is not depicted on the USGS topographic quadrangle map (Exhibit 2) and had discontinuous flow that was

approximately 0-2 inches deep (in riffles and in pools) at the time of our field work. An assessment of this reach resulted in scores of 22.25 and 16.5 using the NCDWQ and DPWES methods, respectively. Stream assessment scores, discontinuous baseflow, and weak geomorphology indicate that this stream is intermittent.

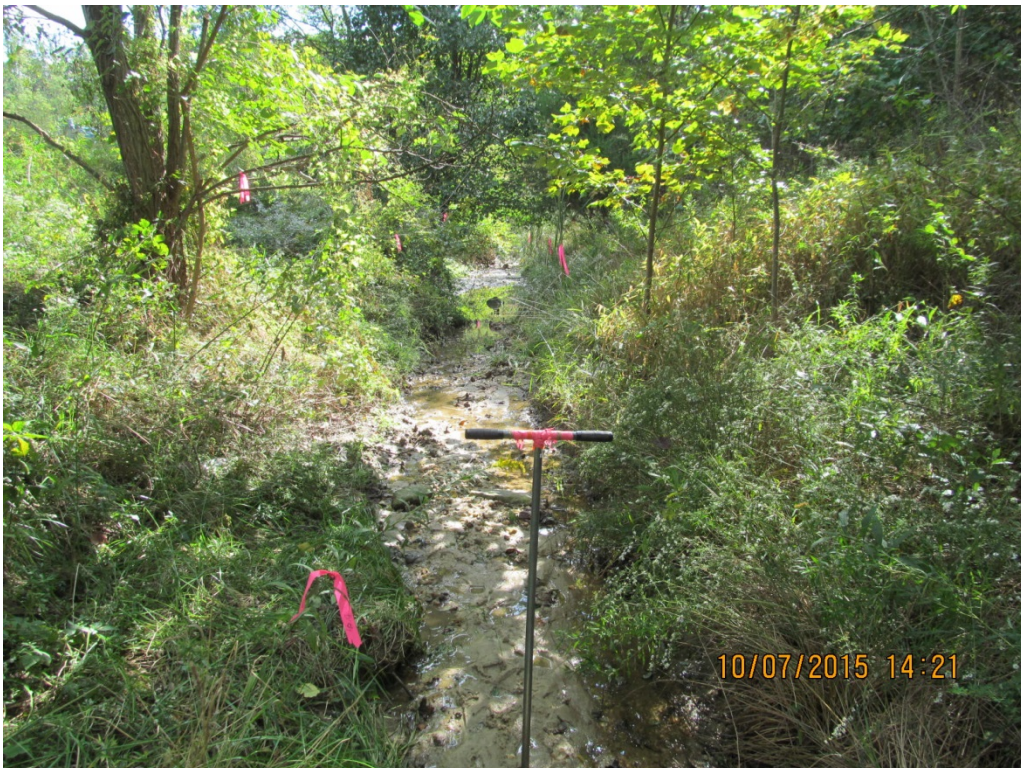
2. Looking south (downstream) at Stream Reach 1-A, which flows southward onto the northern study area boundary.

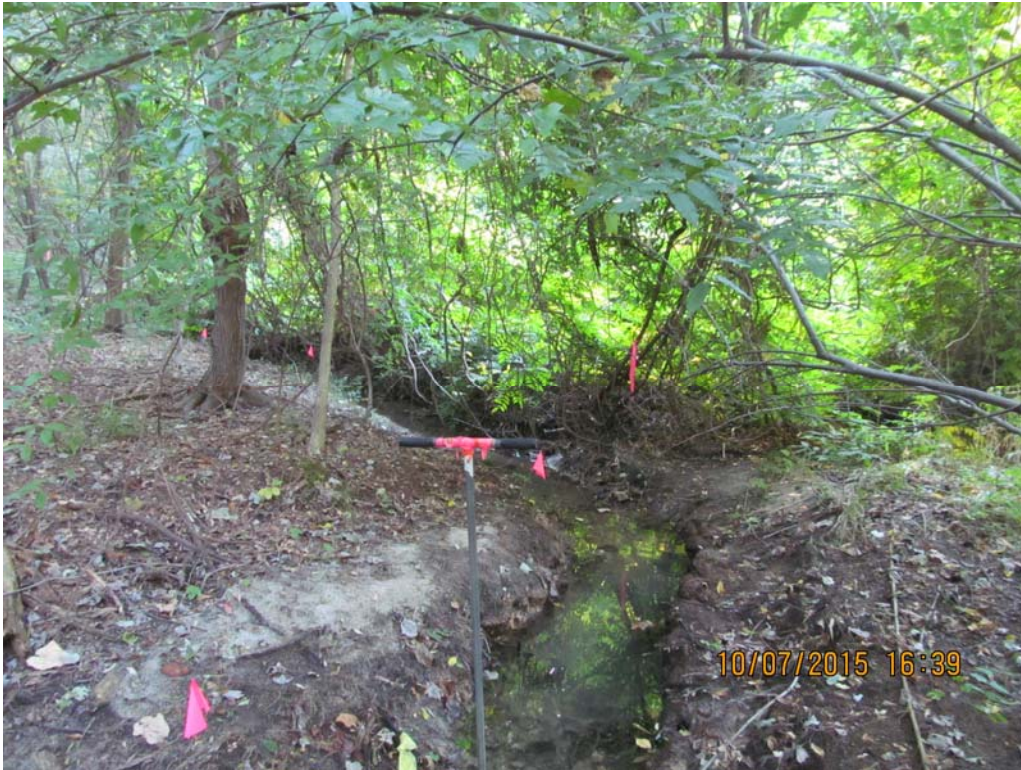
3. Looking southwest (upstream) at Stream Reach 2-A, an intermittent stream present in the northwestern portion of the study area. This stream scored 23 and 17 on the NCDWQ and DPWES methods, respectively. Stream assessment scores below the intermittent/perennial threshold, combined with weak biology and weak in-channel structure, indicate that flow within this stream is intermittent.

- Stream Reach 2-A (Photos #3, #4 and #5) characterizes the stream flagged with the A/D flagging series in the northwestern portion of the study area. This 2- to 6-foot wide stream is depicted by topography alone on the USGS topographic quadrangle map (Exhibit 2) and had discontinuous flow that was approximately 0-4 inches deep (in riffles and in pools) at the time of our field work. An assessment of this reach resulted in scores of 23 and 17 using the NCDWQ and DPWES methods, respectively. Stream assessment scores, weak biology, and weak in-channel structure indicate that this stream is intermittent. In addition, this stream reach was previously assessed during the ECA field work performed in August 2015. During this study, the stream was observed to be dry during a non-drought period thus concluding that this stream is intermittent (Photo #5).

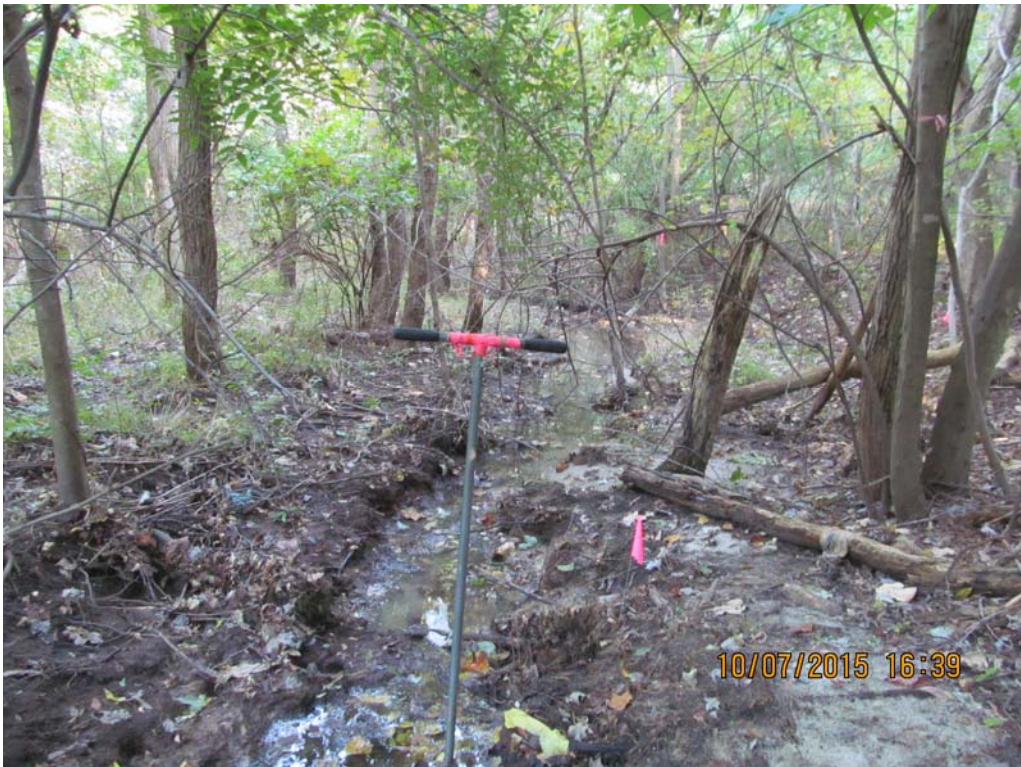
4. Looking southeast (downstream) at Stream Reach 2-A, which flows eastward in the northwestern portion of the study area.

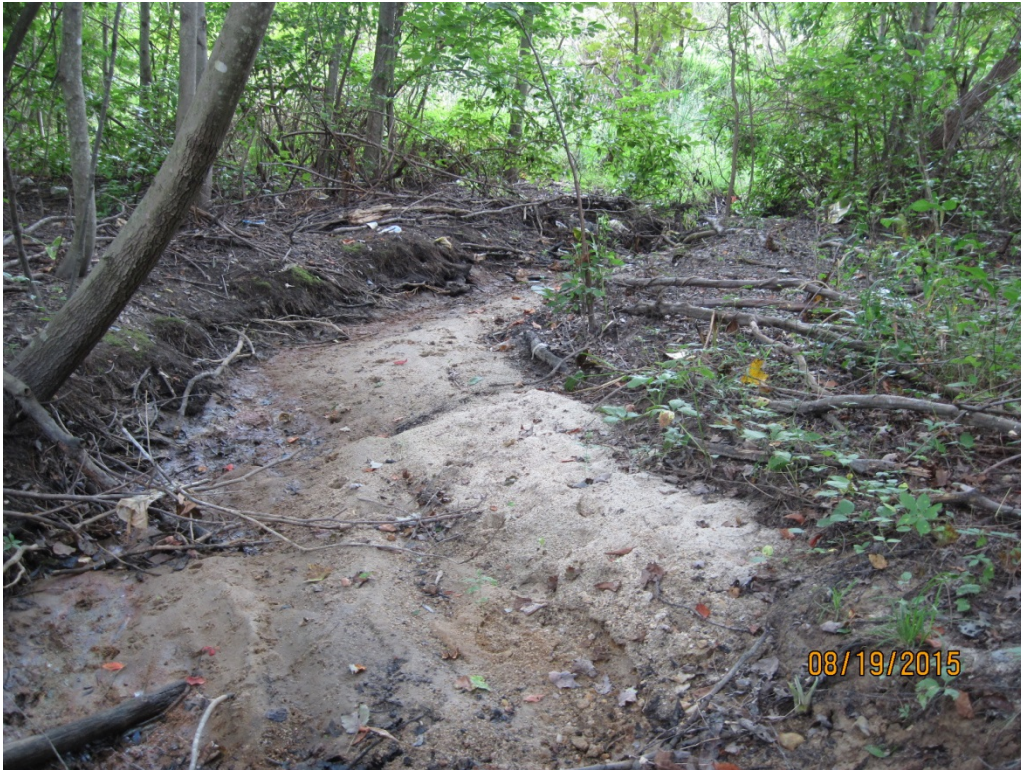
5. Looking east (downstream) at Stream Reach 2-A, which exhibited discontinuous flow during the August 19, 2015 field work for the Milestone – Chinn Park Environmental Constraints Analysis.

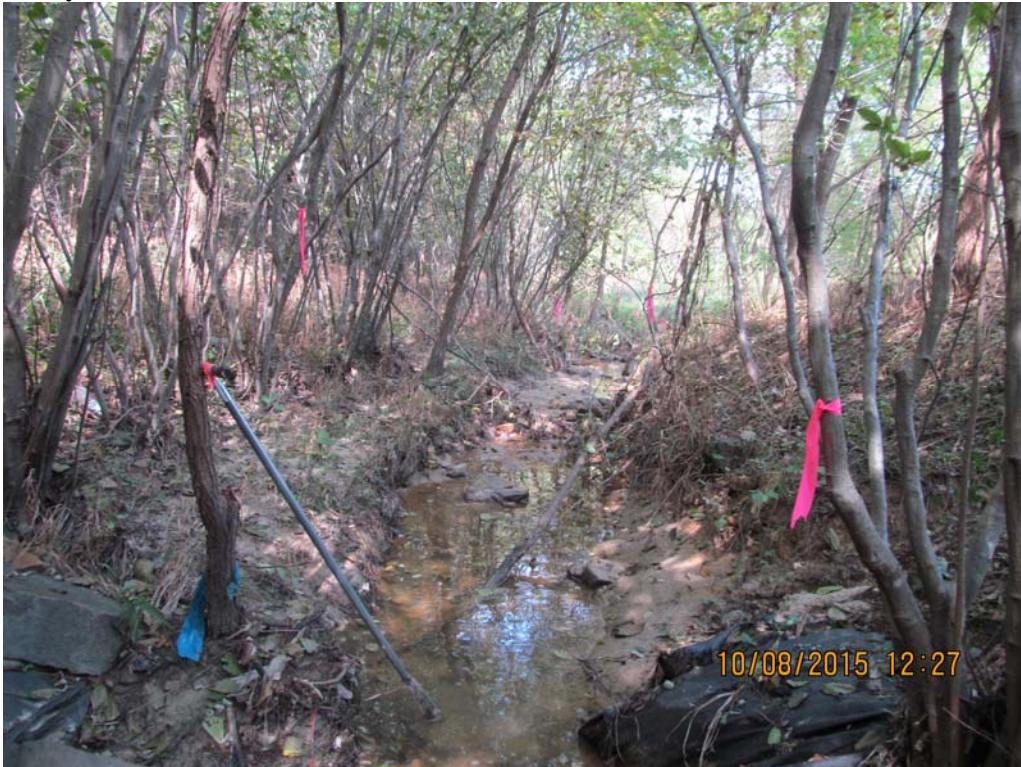
6. Looking northwest (upstream) at Stream Reach 3-A, an intermittent stream present in the northwestern portion of the study area. This stream scored 25 and 20 on the NCDWQ and DPWES methods, respectively. Stream assessment scores below the intermittent/perennial threshold, combined with weak biology, lack of hydric soils, and discontinuous flow, indicate that flow within this stream is intermittent.

- Stream Reach 3-A (Photos #6, #7, and #8) characterizes the stream upslope of Stream Reach 3-B flagged with the A/B flagging series in the northeastern portion of the study area. This 4- to 5-foot wide stream is depicted by topography alone on the USGS topographic quadrangle map (Exhibit 2) and had discontinuous flow that was approximately 1 inch deep in riffles and 4 inches deep in pools at the time of our site visit. An assessment of this stream reach resulted in scores of 25 and 20 using the NCDWQ and DPWES methods, respectively. Stream assessment scores, weak biology, lack of hydric soils, and observation of discontinuous flow indicate that this stream is intermittent. In addition, this stream reach was previously assessed during the ECA field work performed in August 2015. During this study, the stream was observed to be dry during a non-drought period thus concluding that this stream is intermittent (Photo #8).

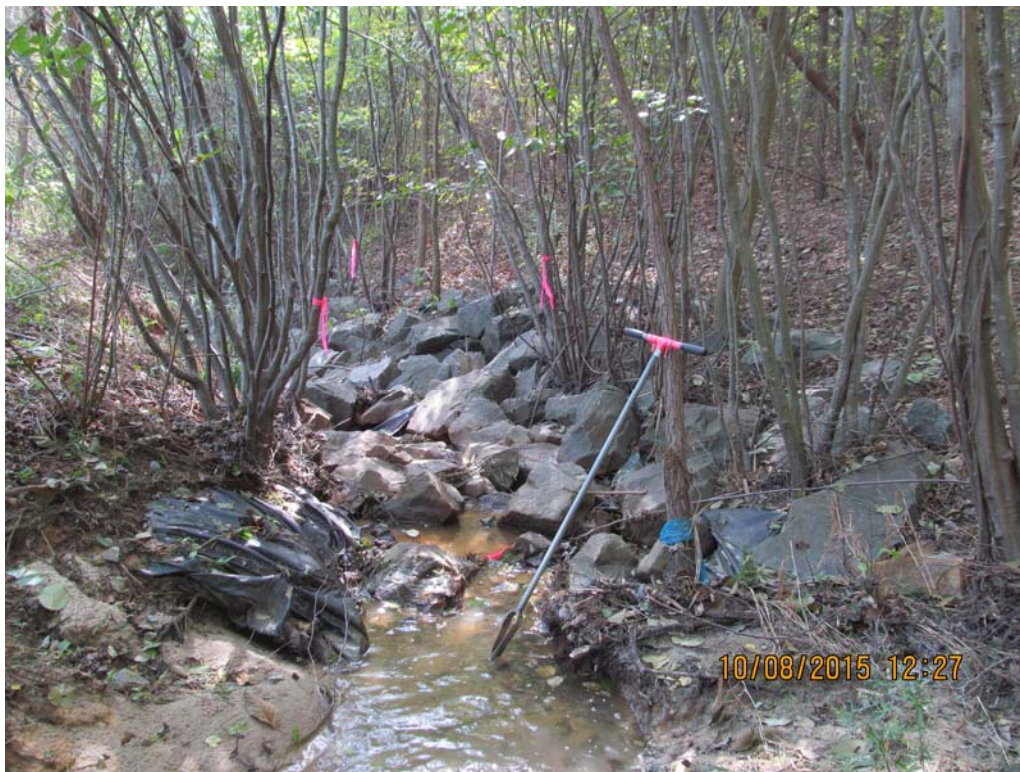
7. Looking southeast (downstream) at Stream Reach 3-A, which flows eastward in the northeastern portion of the study area.

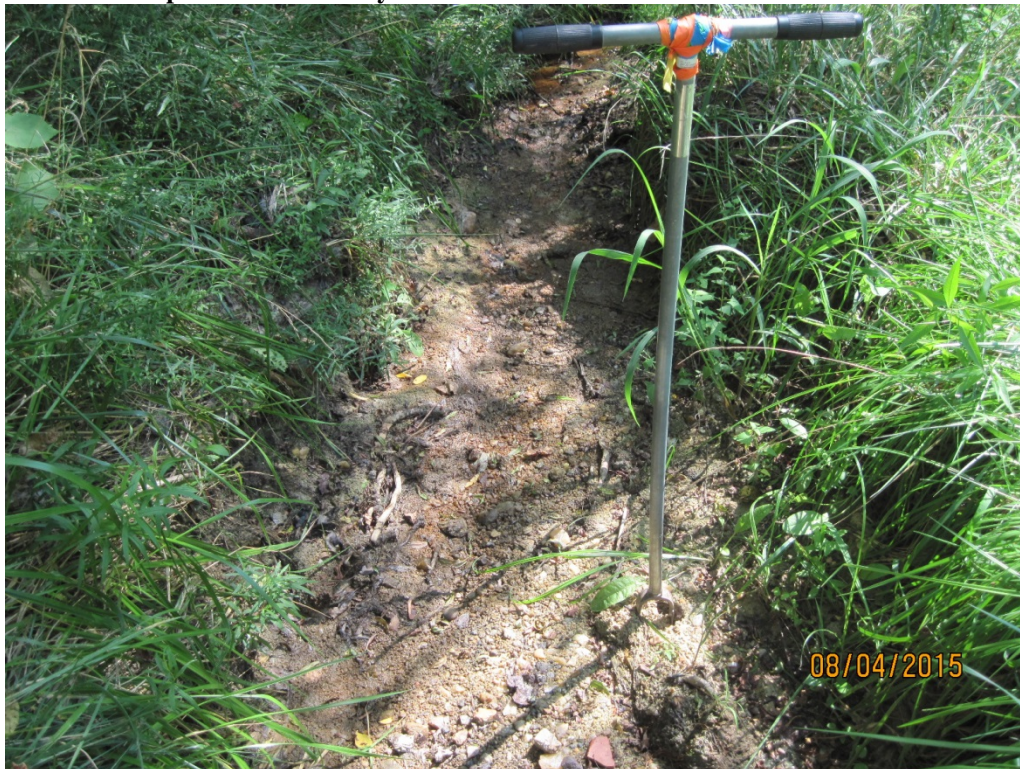
8. Looking south (downstream) at Stream Reach 3-A, which exhibited discontinuous flow during the August 4, 2015 field work for the Milestone – Chinn Park Environmental Constraints Analysis.

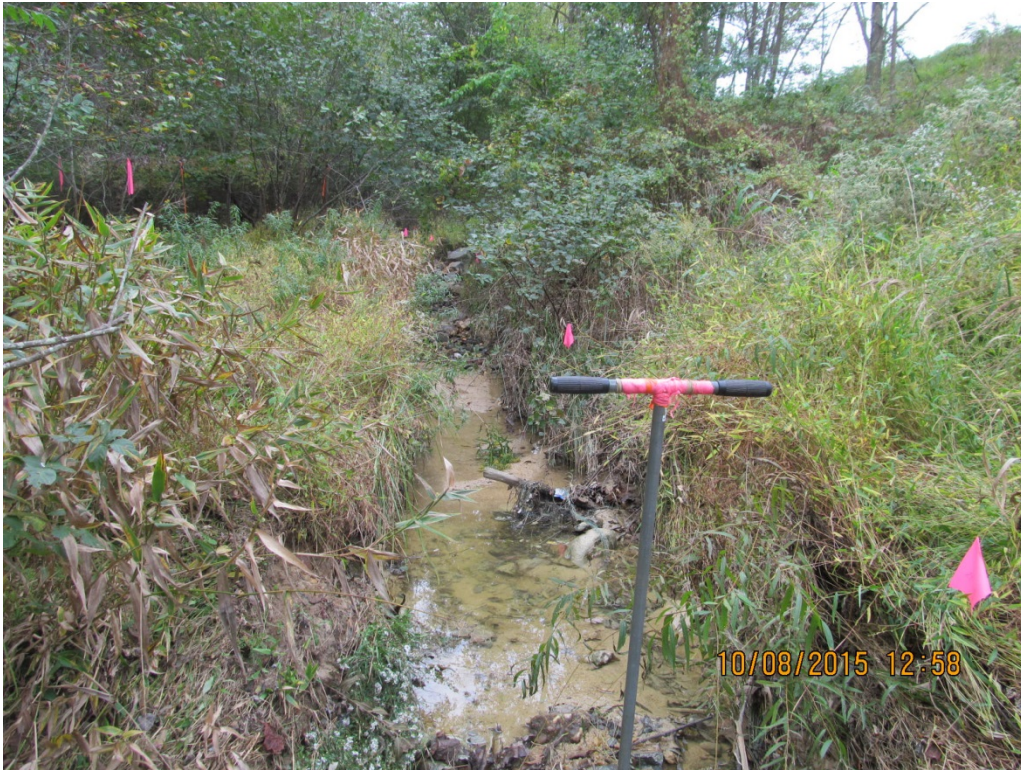
9. Looking west (upstream) at Stream Reach 3-B, a perennial stream present in the northeastern portion of the study area. This stream scored 32.75 and 26.5 on the NCDWQ and DPWES methods, respectively. Stream assessment scores above the intermittent/perennial threshold, combined with moderate baseflow, presence of hydric soils, and an improvement in the geomorphology of the stream below the headcut that served as the break from Stream Reach 3-A, indicate that flow within this stream is perennial.

- Stream Reach 3-B (Photos #9 and #10) characterizes the stream downslope of Stream Reach 3-A flagged with the A/B flagging series in the northeastern portion of the study area. The transition to Stream Reach 3-B occurred below a survey-located headcut. This 2- to 4-foot wide stream is depicted by topography alone on the USGS topographic quadrangle map (Exhibit 2) and had flowing water that was approximately 2 inches deep in riffles and 4 inches deep in pools at the time of our site visit. An assessment of this stream reach resulted in scores of 32.75 and 26.5 using the NCDWQ and DPWES methods. Stream assessment scores are above the intermittent/perennial threshold score for both methods. These scores, combined with moderate baseflow, presence of hydric soils, and an improvement in the geomorphology of the stream below the headcut, indicate that flow within this stream is perennial.

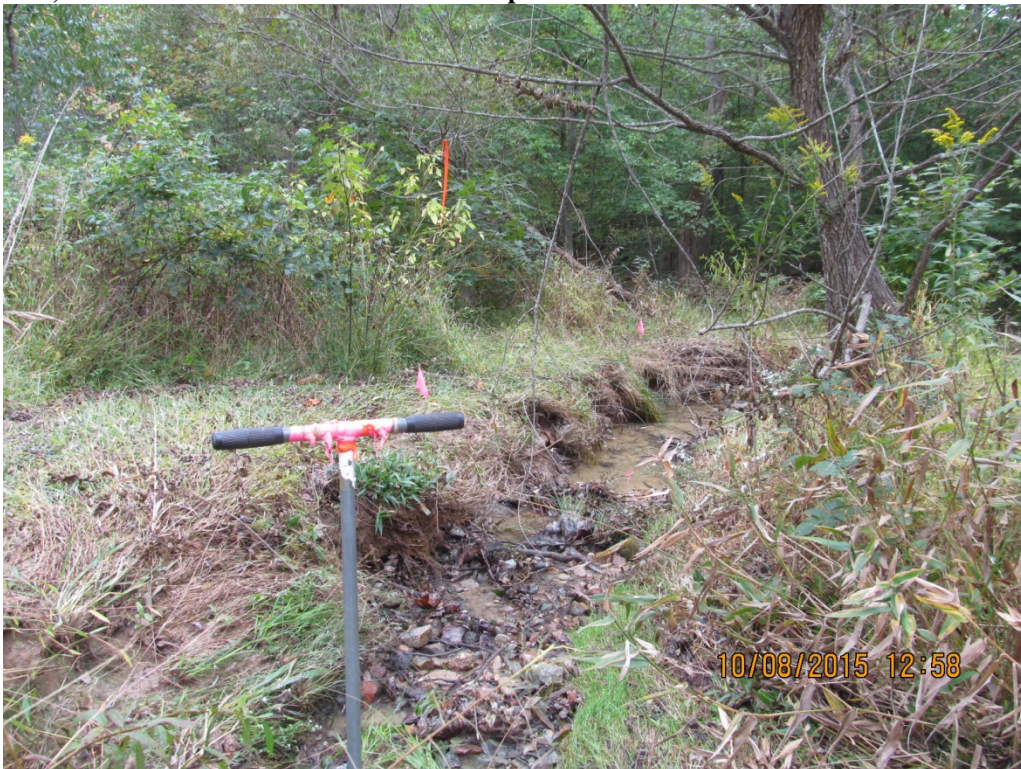
10. Looking southeast (downstream) at Stream Reach 3-B, which flows in an eastern direction in the northeastern portion of the study area.

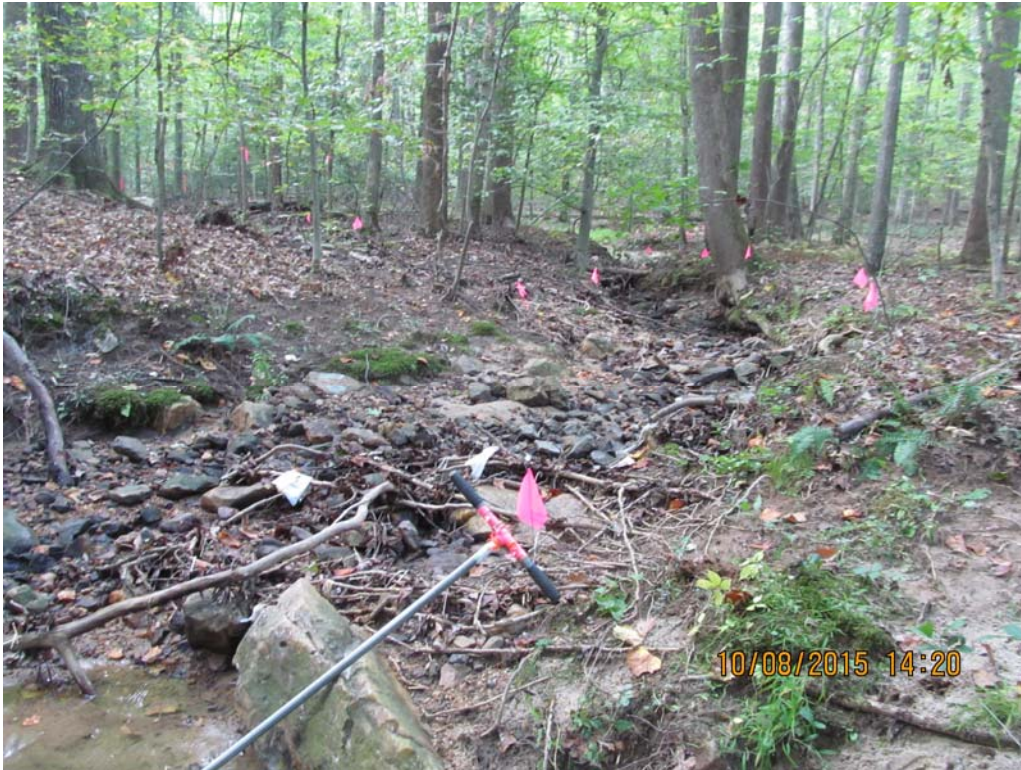
11. Looking southwest (upstream) at Stream Reach 4-A, a perennial stream present in the southeastern portion of the study area. This stream scored 36 and 28 on the NCDWQ and DPWES methods, respectively. Stream assessment scores above the intermittent/perennial threshold, combined with strong baseflow and a second order or greater order channel, indicate that flow within this stream is perennial.

- Stream Reach 4-A (Photos #11 and #12) characterizes the stream flagged with the F/G flagging series in the southeastern corner of the study area. This 4- to 6-foot wide stream is depicted as an intermittent stream (*i.e.*, a thin blue line 0.004 inches wide) on the USGS topographic quadrangle map (Exhibit 2), and had flowing water that was approximately 2 inches deep in riffles and 12 inches deep in pools at the time of our site visit. An assessment

of this stream reach resulted in scores of 36 and 28 using the NCDWQ and DPWES methods, respectively. Stream assessment scores are above the intermittent/perennial threshold score for both methods. These scores, combined with moderate baseflow, and presence of a second order or greater order channel, indicate that flow within this stream is perennial.

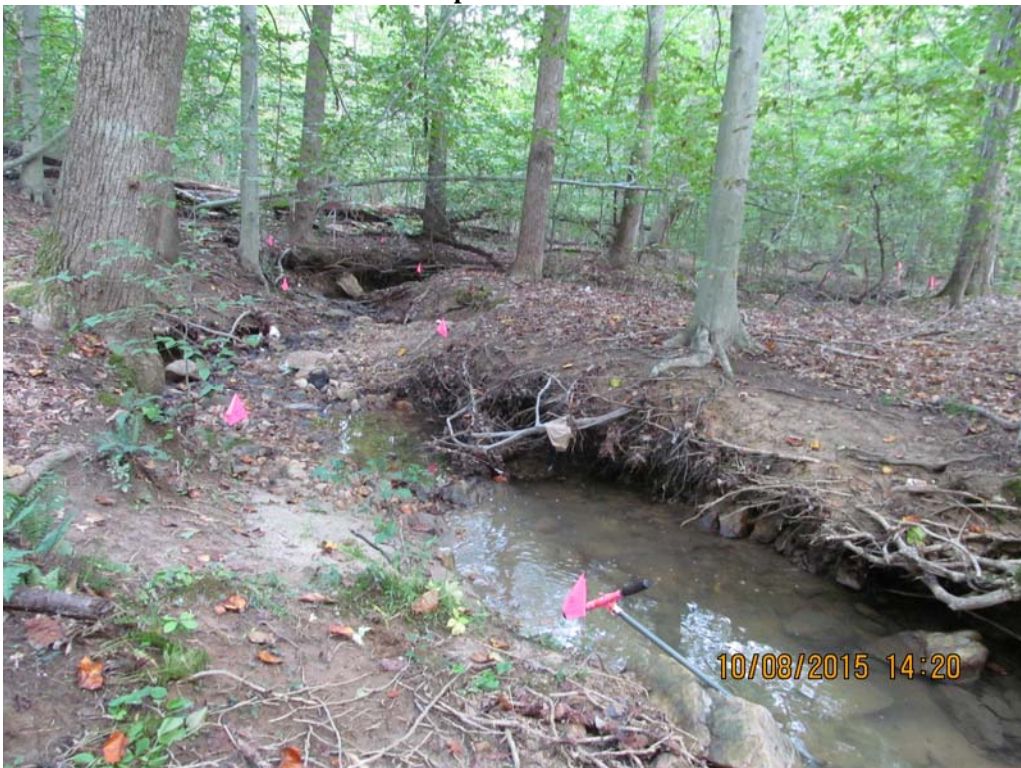
12. Looking northeast (downstream) at Stream Reach 4-A, which flows in a northeastern direction through the southeastern portion of the study area.

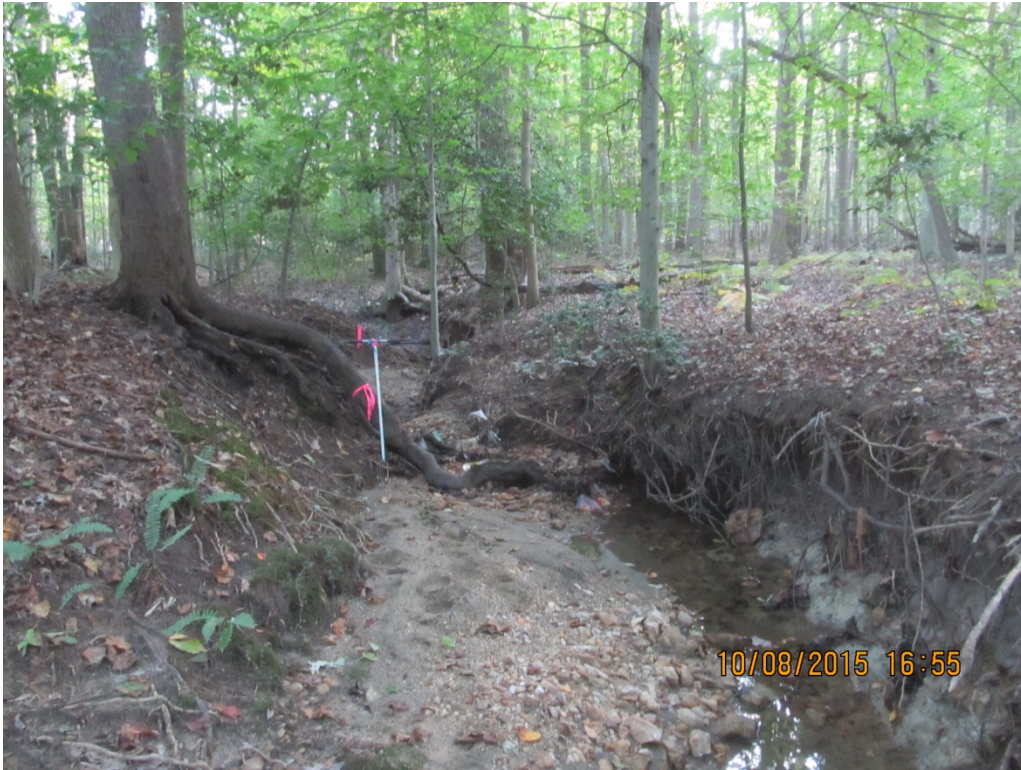
13. Looking south (upstream) at Stream Reach 4-B, an intermittent stream present in the southeastern portion of the study area. This stream scored 23.5 and 18.5 on the NCDWQ and DPWES methods, respectively. Stream assessment scores below the intermittent/perennial threshold in a first-order channel, combined with the absence of biological indicators of perennial flow, indicate that flow within this stream is intermittent.

- Stream Reach 4-B (Photos #13 and #14) characterizes the stream flagged with the I/G flagging series in the southeastern corner of the study area. This 4- to 6- foot wide stream is depicted by topography alone on the USGS topographic quadrangle map ([Exhibit 2](#)) and had flowing water that was approximately 1 inch deep in riffles and 3 inches deep in pools at the time of our site visit. An assessment of this stream reach resulted in scores of 23.5 and 18.5 using the NCDWQ and DPWES methods, respectively. Stream assessment scores below the intermittent/perennial threshold in a first-order channel, combined with the absence of biological indicators of perennial flow, indicate that flow within this stream is intermittent.

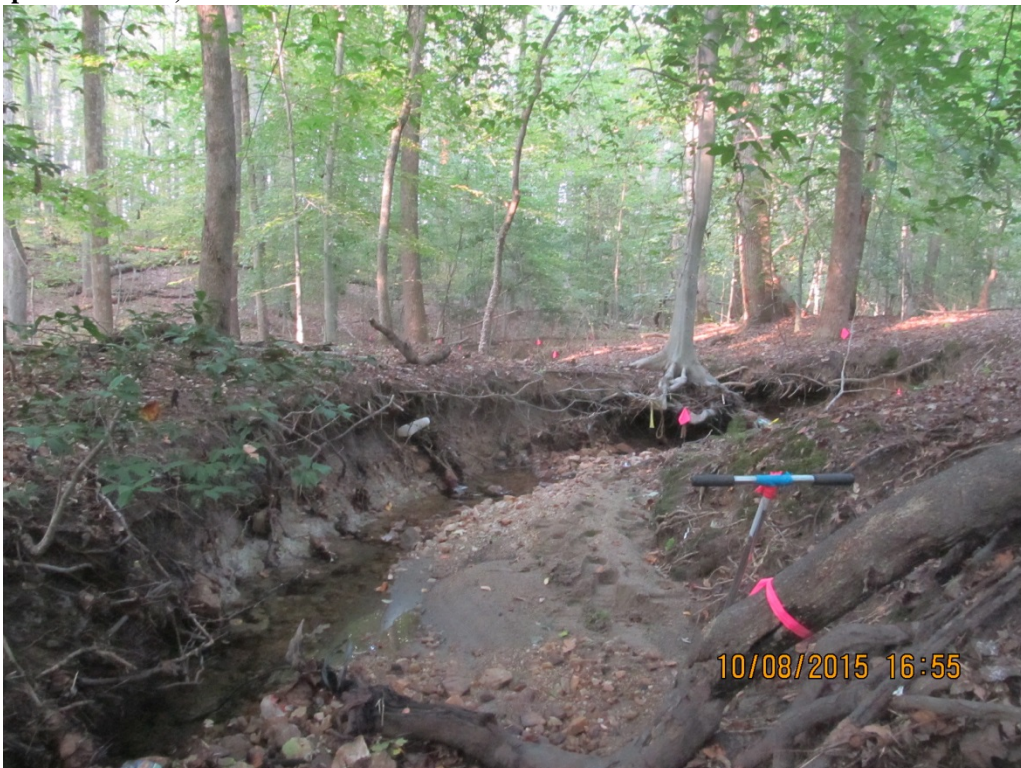
14. Looking northeast (downstream) at Stream Reach 4-B, which flows in a northern direction through the southeastern portion of the study area.

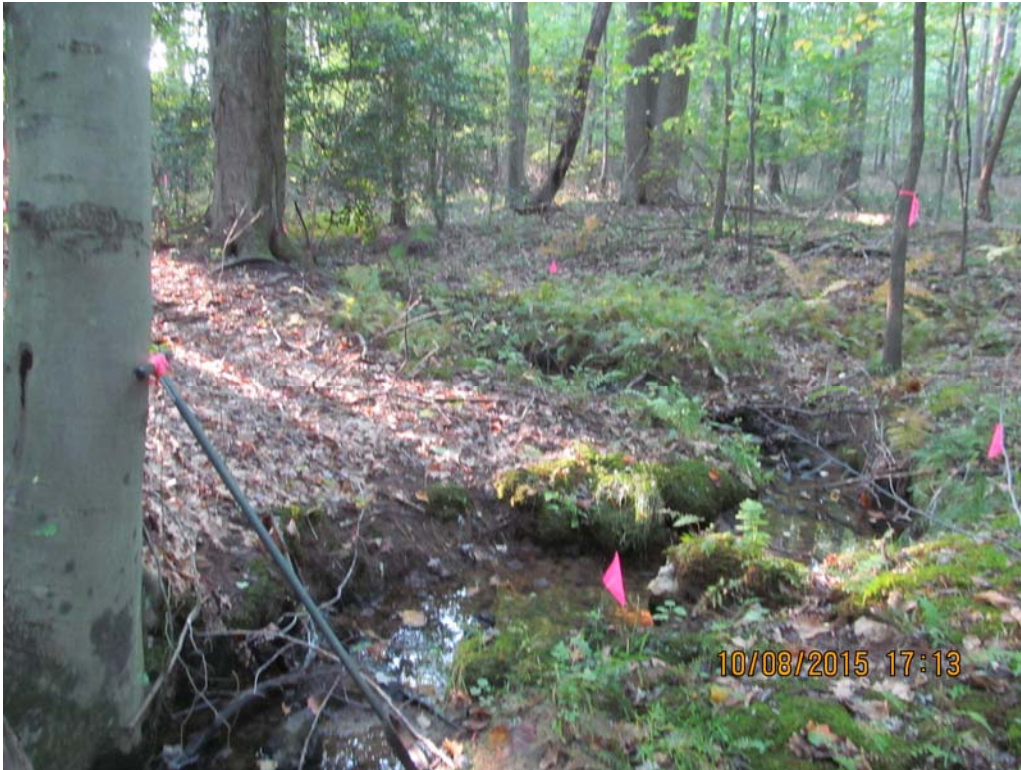
15. Looking northwest (upstream) at Stream Reach 4-C, an intermittent stream present in the southeastern portion of the study area. This stream scored 27 and 22 on the NCDWQ and DPWES methods, respectively. Stream assessment scores below the intermittent/perennial threshold in a first-order channel, combined with the absence of biological indicators of perennial flow, indicate that flow within this stream is intermittent.

- Stream Reach 4-C (Photos #15 and #16) characterizes the stream flagged with the J/K flagging series above its confluence with Stream Reach 4-B, located in the southeastern corner of the study area. This 2- to 3- foot wide stream is depicted as an intermittent stream (*i.e.*, a thin blue line 0.004 inches wide) on the USGS topographic quadrangle map ([Exhibit 2](#)) and had flowing water that was approximately 2 inch deep in riffles and 4 inches deep in pools at the time of our site visit. An assessment of this stream reach resulted in scores of 27 and 22 using the NCDWQ and DPWES methods, respectively. Stream assessment scores below the intermittent/perennial threshold in a first-order channel, combined with the absence of biological indicators of perennial flow, indicate that flow within this stream is intermittent.

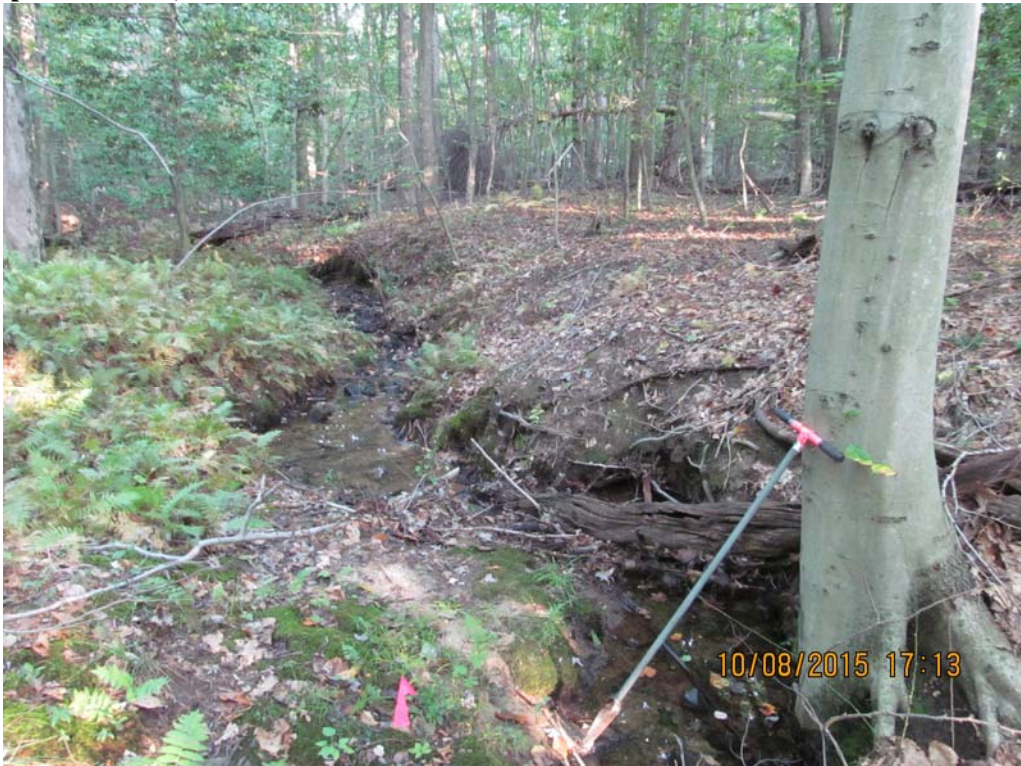
16. Looking southeast (downstream) at Stream Reach 4-C, which flows in an eastern direction through the southeastern portion of the study area.

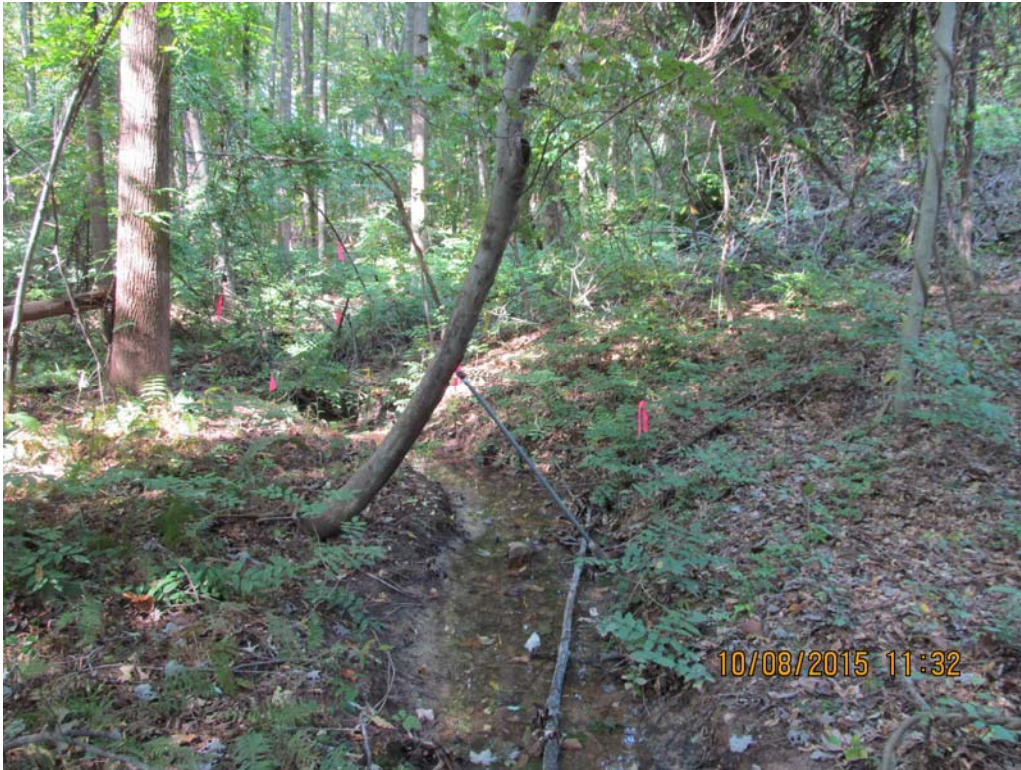
17. Looking west (upstream) at the intermittent tributary present in the northwestern portion of the study area. This stream was too short to assess but because it has a continuous ordinary high water mark, has hydric soils, and is upstream of Stream Reach 2-A, an assessed intermittent tributary, this stream reach is considered intermittent.

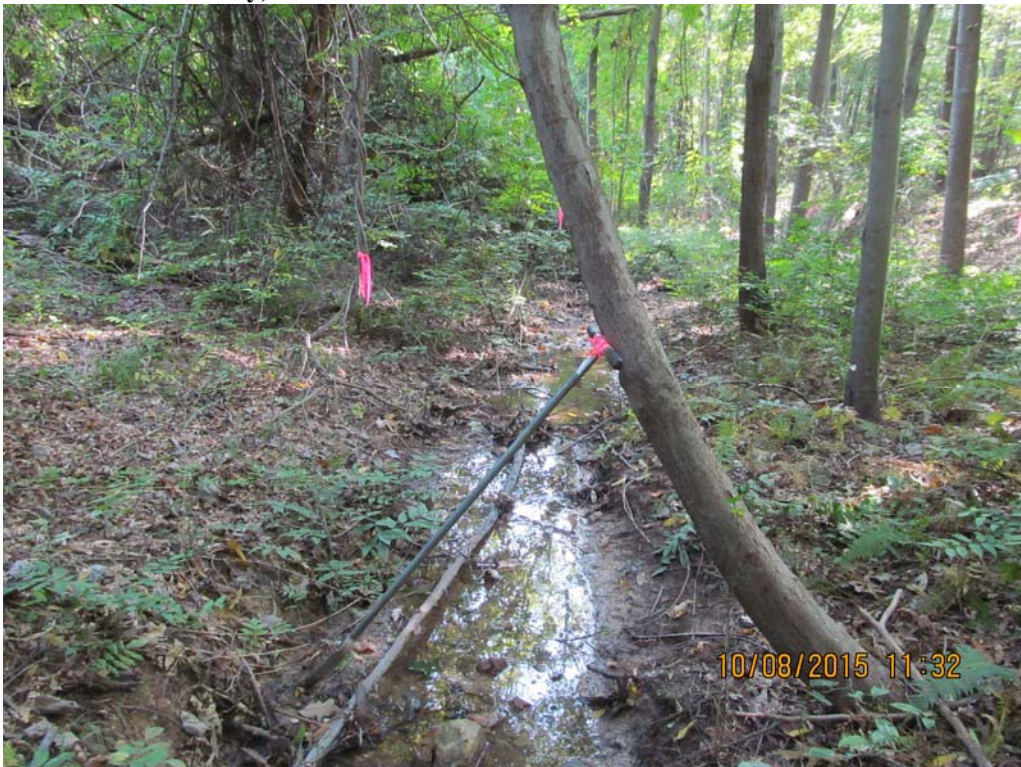
18. Looking east (downstream) at the intermittent tributary which flows in an eastern direction through the northwestern portion of the study area.

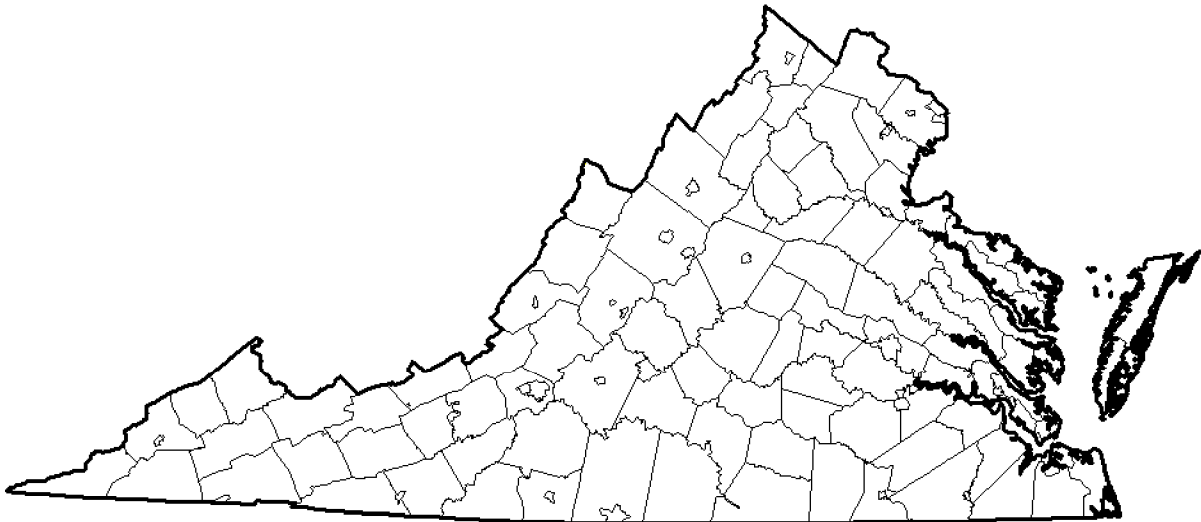
U.S. Drought Monitor Virginia

October 6, 2015
(Released Thursday, Oct. 8, 2015)
Valid 8 a.m. EDT

WSSI also reviewed the Palmer Drought Severity Index (Exhibit 7) and U.S. Drought Monitor (Exhibit 8) maps to determine if drought conditions were present at the time of the stream assessment field work. Both the Palmer Drought Severity Index Map and the U.S. Drought Monitor Map indicate that the stream evaluation field work was completed during a period of near normal precipitation.
